1. Introduction

This document summarizes the inspections and measurements of the defect in the FLAMES corrector lens, which were made by ESO staff in August 2023.

1.1 Initial Detection of the Defect

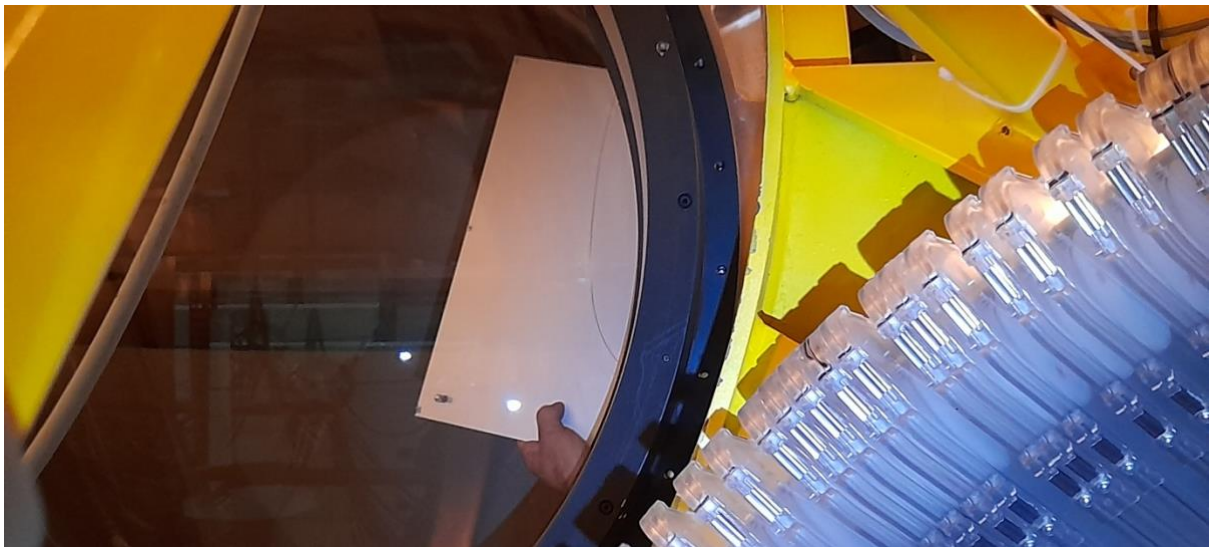
The lens defect was initially noticed and inspected in November 2022. It seemingly reaches the edge of the lens on both ends, i.e. is unlikely to grow further (and has not grown since November 2022).

A line defect is clearly visible in figure 1. The defect is in the diverging lens of the corrector (the lens closest to the focal plane). It was also found that parallel to the original defect, 'crack propagation lines' were found, although faint.

Figure 1: The defect shortly after its discovery

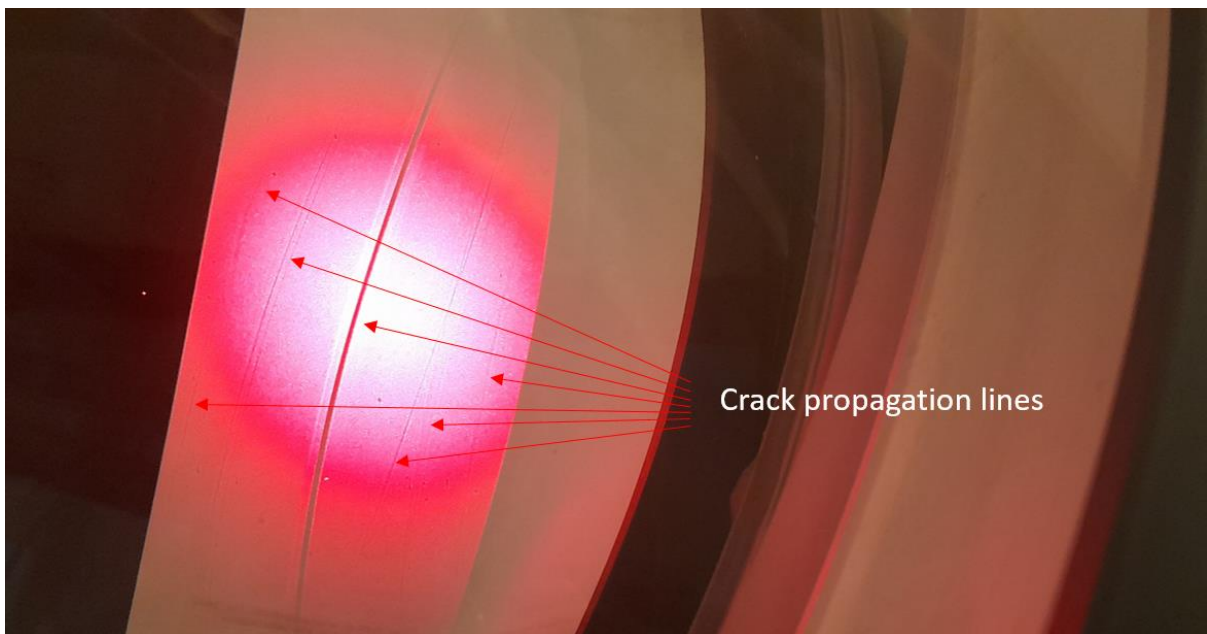
Figure 2: Crack propagation lines were detected as well

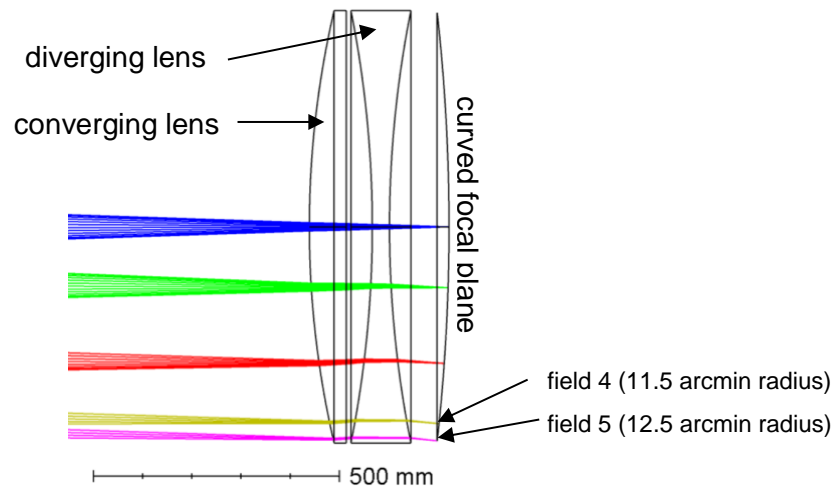
As the converging lens is very close to the focal planes where the FLAMES fibres are located, the footprint of any defect is small, so the impact is very localised. The defect protrudes about 7cm into the lens, which translates to about 11.5 arcmin radius from the centre of the field. In this area close to the edge of the FoV (12.5 arcmin maximum) significant vignetting is already present, and in general, many PIs already avoid this area for that reason. However, in order to minimize any effect on any of the fibres placed by PIs, measures need to be taken and/or the impact on the data understood.

Figure 3: The beam from the telescope passing through the corrector lens

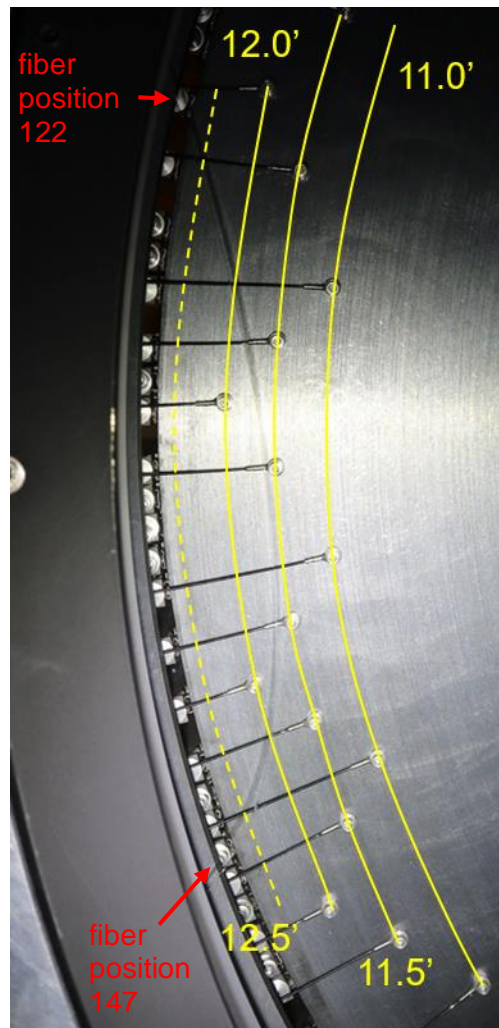
Figure shows an image of the line defect as viewed from the Nasmyth tube with fibres placed strategically behind it. The line defect extends to about 11.5 arcmin FoV from the center of the FoV. The ends at the maximum diameter of the lens are close to fibre 122 and fibre 147, corresponding to an angle from the centre of the plate of about 34° .

Figure 4: The defect as viewed from the Nasmyth tube (note that in this image, the defect is viewed at an angle at the ends and thus the projection of the defect does not exactly correspond to the fibre numbers stated in the text)

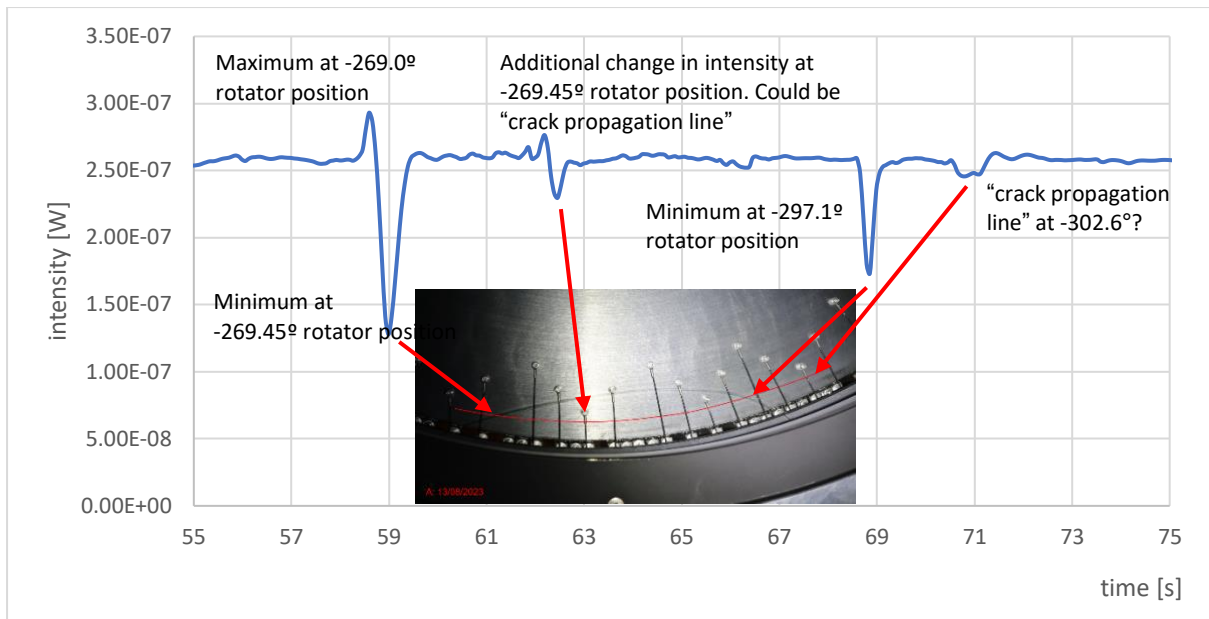
Figure shows the intensity when tracking across the defect. The two crossings at the line defect are clearly visible with intensity reductions of roughly 50% and 30%. The first passing also shows an increase in intensity before decreasing. This is likely to a result of reflection and diffraction of the light when crossing the defect. An additional change in intensity can be seen in between both crossings of the line defect. A possible explanation could be the “crack propagation lines”.

Similar measurements were made at different radii in the focal plane, i.e. across different sections of the crack, with similar results.

Figure 5: Intensity during rotator movement for measurement across one section of the defect.

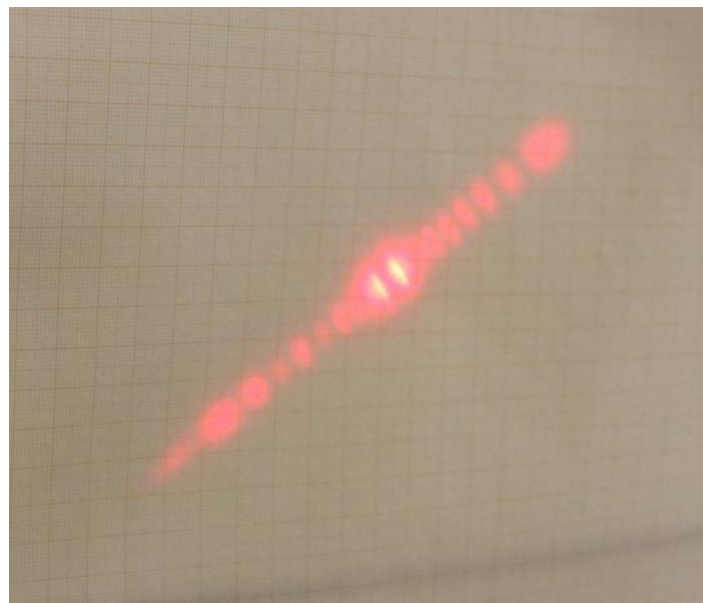
After the laser measurements a millimetre paper was used as a screen at a distance of approximately 3.5 m from the lens defect. When positioning the line defect at the minimum intensity positions, a diffraction pattern perpendicular to the direction of the defect could be observed (see **Error! Reference source not found.**). Assuming diffraction at a single slit (i.e. the negative of the line defect), the width of the defect can be estimated to 0.37mm.

Figure 2: The interference pattern at one of the minima visible in Fig 5.

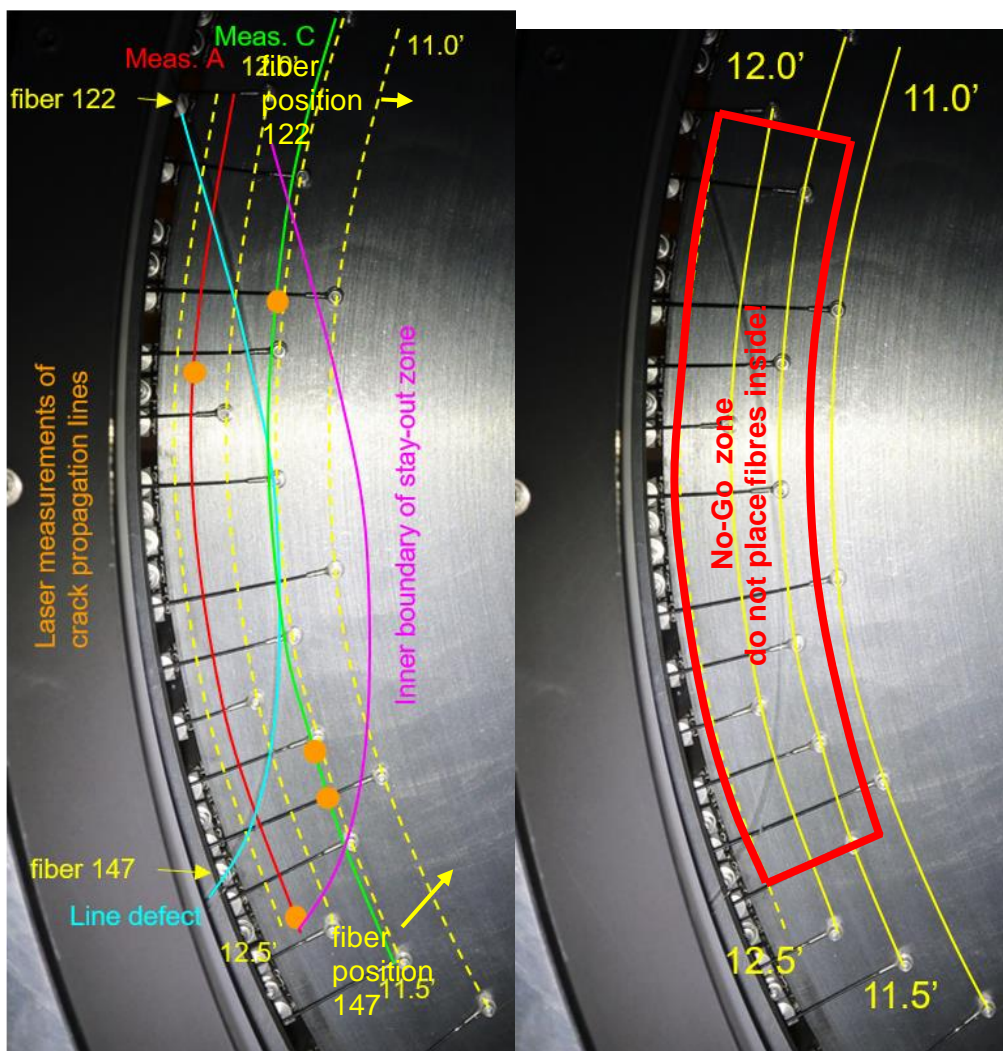
Figure 3: Left: The position of the line defect and the propagation lines. Right: The proposed no-go zone for the fibres in red from fibre 122 to fibre 147 (both included) and distance to the field centre >11.2 arcmin.

While the exact effect on data of fibres placed in the area of the defect is extremely difficult to measure as it will be wavelength, position and condition (seeing?) dependent, the field corrector lens is rotating with the fibre plate. As such, the defect impacts a fixed area on the plate, instead of potentially affecting any fibres placed beyond 11.5". As a result, we propose a no-go zone for the fibres, slightly larger than the area of the defect itself.

In order to limit the impacted area, we have decided to introduce a tight no-go area that covers only the defect itself (starting at fibre position 122, ending at 147 with a distance to the field centre of larger than 11.2 arcmin), but excludes some of the crack propagation lines that could have some impact on the data. While this effect would be smaller, PIs should be aware of the possible small effect on their data in this area.
