The Quality of the 3.6m main mirror

A. GILLIOTTE

With this note, a brief history of the 3.6m main mirror is given, together with a summary of the actions that have been and will be taken to better understand the problems affecting this unit.

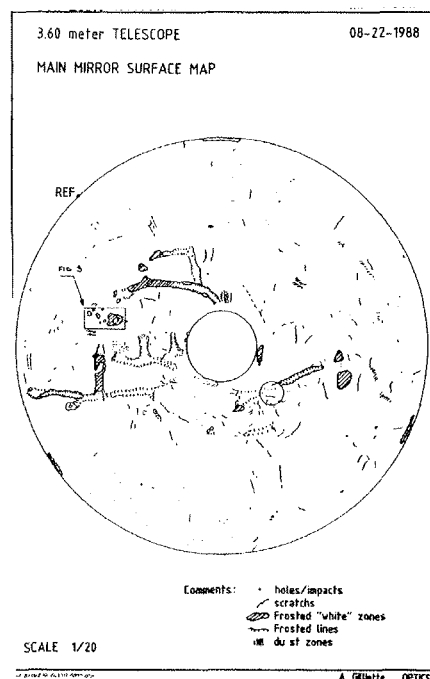
Figure 1.

In Figures 1 and 2, the maps of the 3.6m main mirror, as recorded in 1988 and 1994, are presented. The comparison between these maps show the evolution of the blemishes in the last 6 years. During these years some new frosted zones close to the mirror center, affecting less than 0.2 percent of the mirror area, appeared. Please note that, due to the manual design of the maps, the maps give a picture which appears worse than in reality. This is due to the fact that all the defects are drawn with the same intensity, regardless of their true effect. Figure 3 shows a picture of a

small affected area (also indicated in Figure 1) with a frosted zone and spots, which appear as white regions. The size of the larger frosted stain is 70mm. Despite the low contribution of these defects to the overall telescope efficiency (see below), it was decided to establish a diagnostic of the mirror "illness", in the framework of the 3.6m + CAT Upgrade Plan.

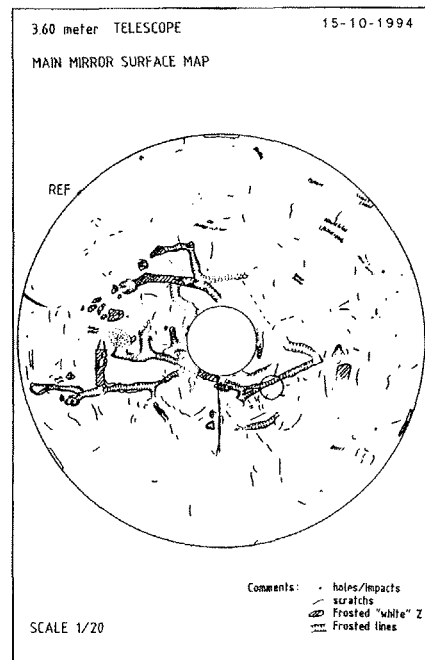
Figure 2.

ones. The rugosity (a measure of the roughness), which is 15 \AA for an excellent mirror, varies from 60 \AA in a good zone to 140 \AA in an affected one. Dust on the mirror produces a similar roughness of about 120 \AA . The zones affected by the defects cover only 2% of the whole mirror surface. The contribution of the defects on the overall telescope efficiency is negligible, in comparison to that produced by dust.

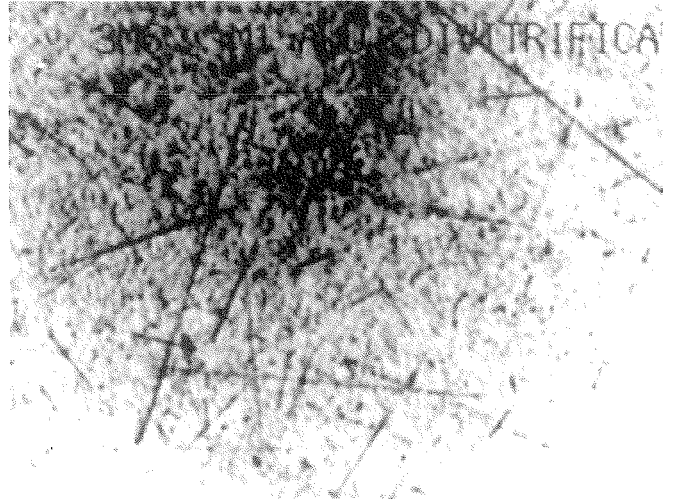
Figure 4.

During the last aluminisation qualification of the frosted zones began, using both magnified surface images and the measured reflectivity of the affected areas. In Figure 4, the transition area between a frosted spot and a sound zone is shown. The spot appears in black and the magnification of the picture is 135, giving a spot diameter of about 0.5mm. A grain structure is easily visible, with a grain size of about 3 microns.

The next aluminisation of the 3.6m main mirror is anticipated during June 1996. The frosted areas will be analyzed with higher precision. Specific instrumentation will be used to characterise

- A phase contrast microscope will be provided by REOSC and used to figure out the depth of the defects. This instrument is also used to characterise the VLT mirror surface quality.
- An Atomic Scale Tribometer will be also used to map precisely the surface with a very high resolution.
- Surface images with a magnification of 270 will help detail the grain structure.
- Following the results of these tests a small sample of one of the affected zo-
