# Cleaning of extremely sensitive optical surfaces

Jean Louis Lizon\*<sup>a</sup>, Sebastian Deiries<sup>a</sup>

<sup>a</sup>European Organisation for Astronomical Research in the Southern Hemisphere, Karl-Schwarzschild Str. 2, D-85748 Garching b. München, Germany

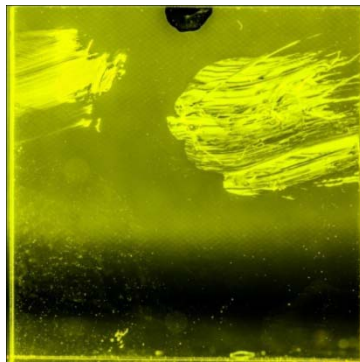
Figure 1. Optical glass contaminated with 4 different contaminants (thermal grease, vacuum grease, finger-print and dust)

Figure 1 shows a glass plate (optical filter) which is heavily contaminated with dust but also with grease (unavoidable in most of optical instruments) and also some accidental trace of finger print. Figures 2 and 3 show a very common type of contamination for sensitive surfaces of optical detectors. These components are generally operated at cryogenic temperatures inside a vacuum chamber. The detector which is one of the coldest points of the system tends to cryo-trap most of the residual gas of the chamber. Some of this contamination could be water vapor and will for a large part disappear during the next warming up. This happens, if the “working point” of the detector is inappropriate (too much water vapour in the vacuum) in the water phase diagram at the border of vapour and solid state at 0.01 Pa and -100°C.

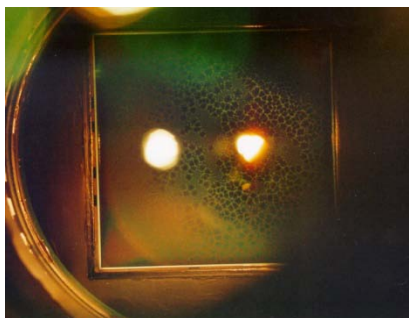
Figure 2. Contamination of 2x2k Tektronix backside thinned CCD detector with grease shows crocodile pattern

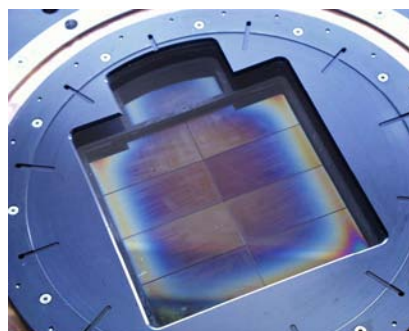
Figure 3. WFOV optical CCD mosaic with typical cryostat contamination (water vapor monomolecular layer and maybe some hydrocarbons)

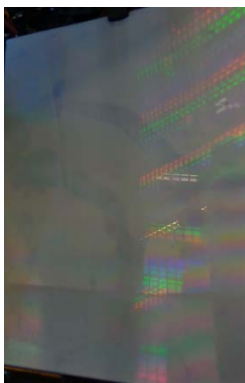
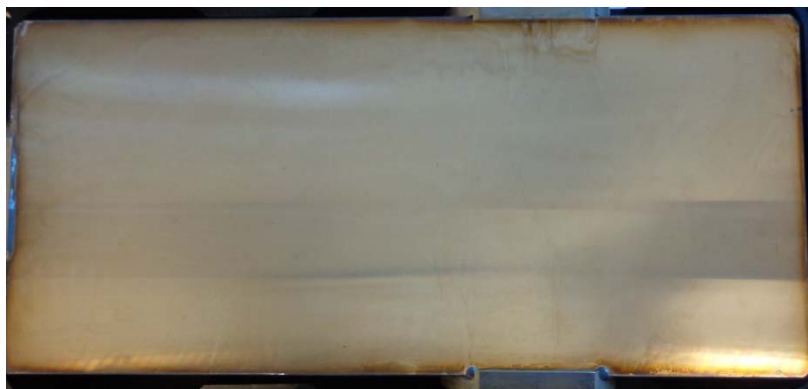
Figure 4. Contaminated ECHELLE grating

Unfortunately this contamination might be more serious and leave stains on the surface also other source like vacuum grease could contributed to this contamination and a dedicated cleaning of the surface would be required in order to restore the full performance of the detector. Figure 4 shows also on the left side a normal contamination with dust of the surface of an echelle grating while the right side of the photograph show a silver coated grating which has been tarnished due to contact with air.

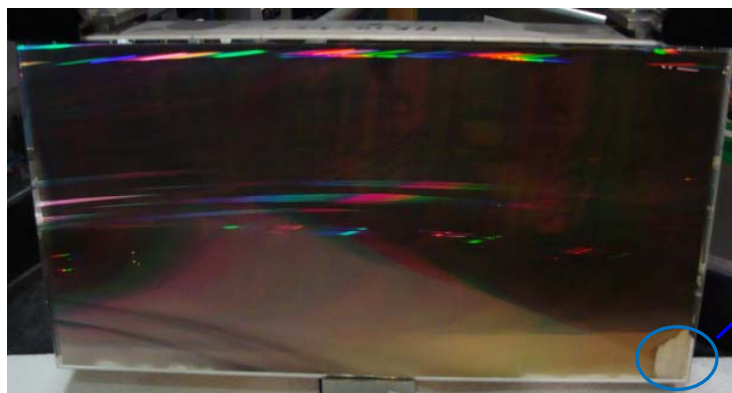
Figure 5. Grating after a local cleaning test

The cleaning was carried out with a diluted solution used by numismatic collectors for cleaning of silver coins. This cleaning which allows a very efficient recovering of the original shining of the silver has the disadvantage to leave very damageable trace and stain of salt on the surface if it is not removed extremely rapidly. For this reason the silver cleaning method has been applied in combination with an acetone vapor cleaning. The grating has been sprayed with the silver cleaning solution and with a few minutes vapor cleaned. For the vapor cleaning the grating was kept with the optical surface facing the acetone container and slightly tilted (~15 degrees) around the perpendicular to the groove. This orientation guarantees an efficient and continuous cleaning of the groove.

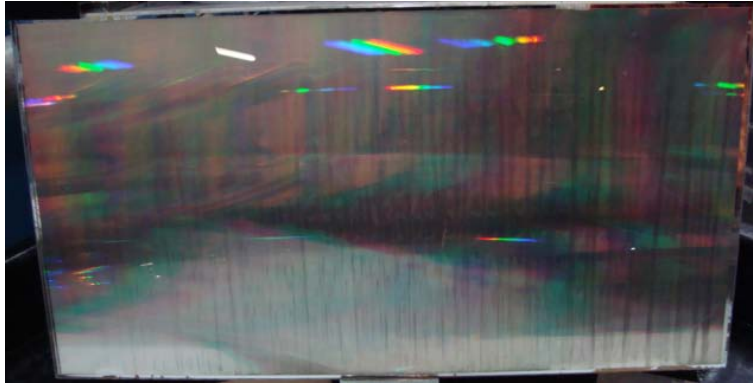
Figure 6. Grating after full cleaning

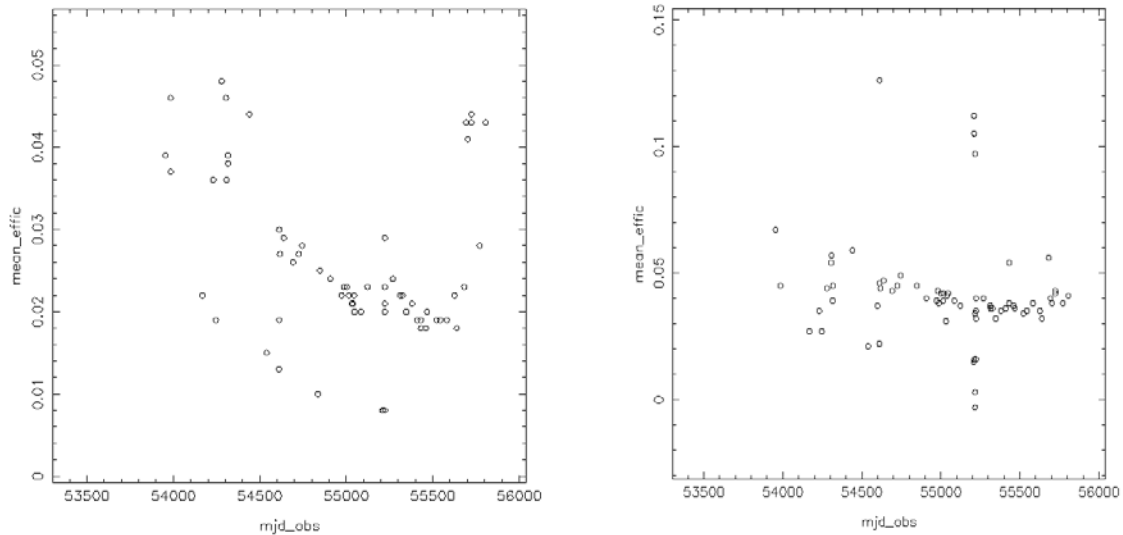
Figure 7. evolution of Giraffe system efficiency in HR mode, measured on standard stars (at 447 nm left and 652 nm right). The decrease with time is fully attributable to tarnishing of the HR grating. The grating was washed with a silver-cleaning solution around MJD 55750.

This effect has been followed out and analyzed on the grating of one of our spectrograph (Giraffe). Figure 7 shows the evolution of the Giraffe system efficiency in HR mode, measured on standard stars measured for two different wavelengths at 447 nm (left side) and 652 nm (right side). Between MJD 54000 and 55700, the system efficiency (top of the atmosphere to detected photoelectrons) decreased from an average 0.045 to 0.018 at 447 nm, a factor 0.4 over 1700 days. The decrease with time is fully attributable to tarnishing of the HR grating.

Figure 7 shows how the efficiency of the complete instrument in the blue could be almost completely recovered after the cleaning of the grating.

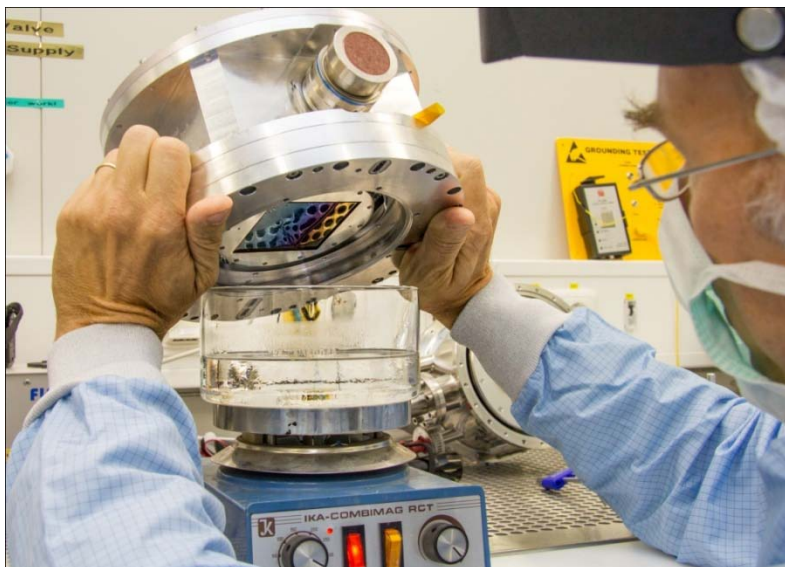
Figure 8. Complete cryogenic vessels can be placed into alcohol or acetone vapors

The following photographs show the sequence use for the cleaning of the detector using the alcohol vapor. The alcohol contained in a small container has been brought to boiling using a small heater. Then the complete detector assembly has been kept on top of the bath with the detector oriented such that the bond wires are vertical in order not to apply to much stress to these, which could disconnect them, making the detector inoperable.

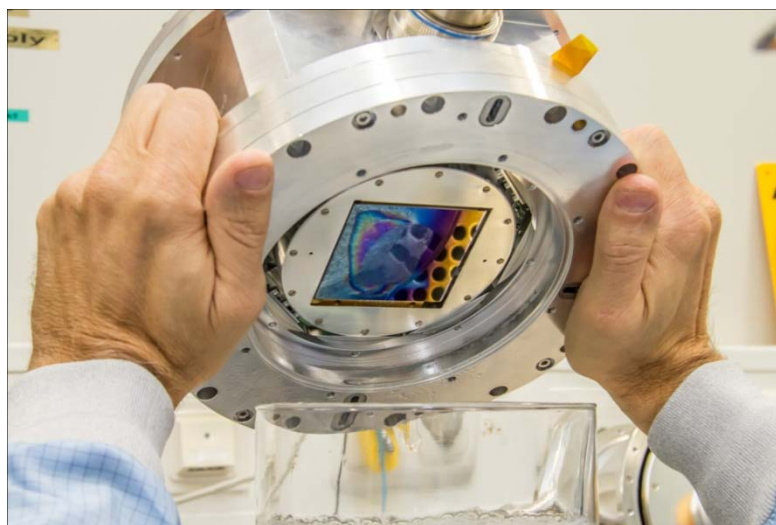
Figure 9. Alcohol vapor is condensing at the detector surfaces

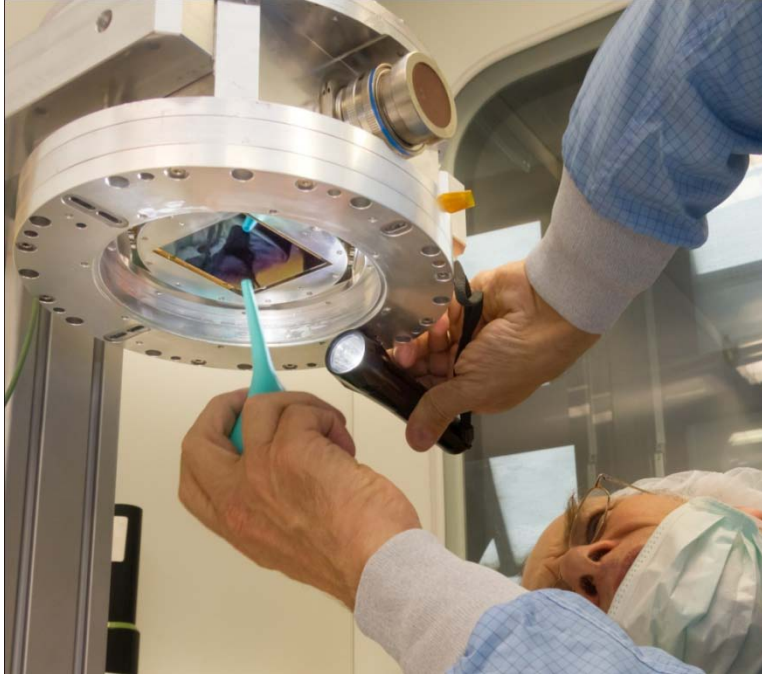
Figure 10. Inspection of the vapor cleaned surface and blowing off of last dust particles

This cleaning technique is very efficient for removing most of the residual traces of grease by direct solving. It also helps to remove some very strongly adhering dust particles. Only a last verification completed with a soft blowing is then required in order to fully restore the original cleanliness of the detector.

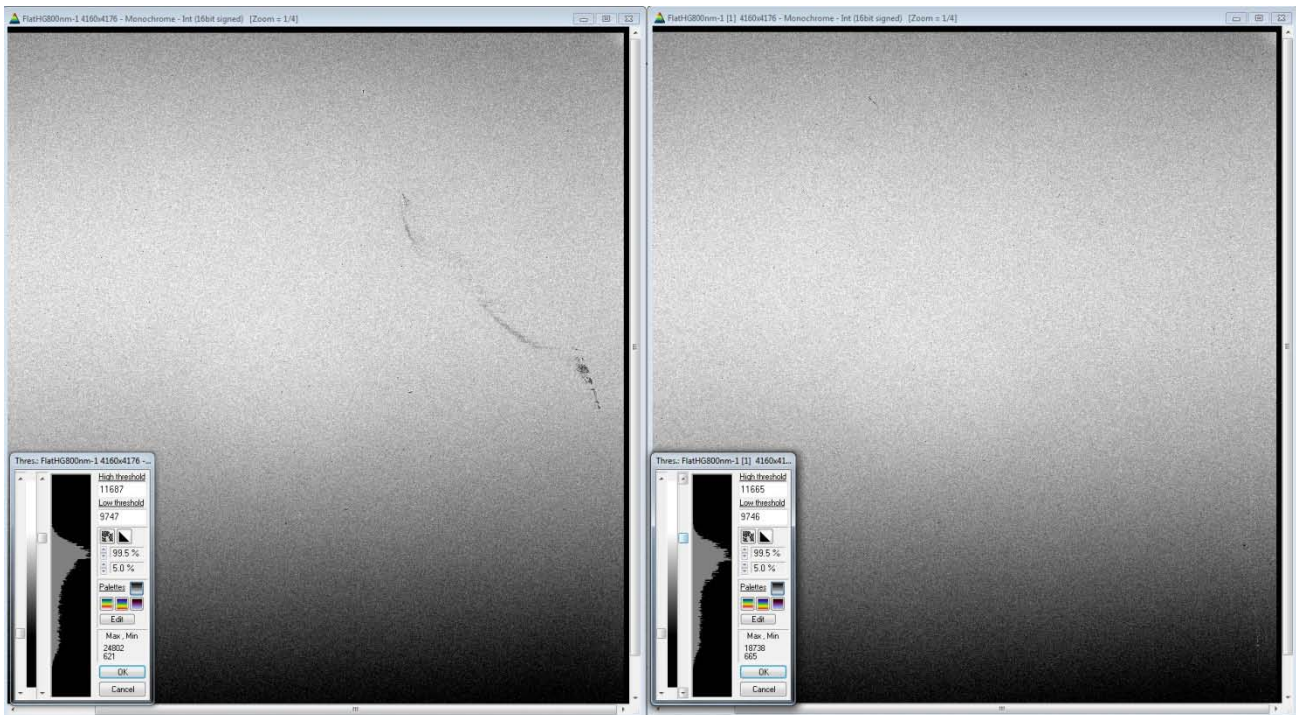
Figure 11. Flat-field of detector before (left) and after (right) vapor cleaning

Figure 11 shows the is very convincing result: the grease-contamination at the MUSE CCD has completely dis-appearing after vapor cleaning as seen in the taken flat-fields:

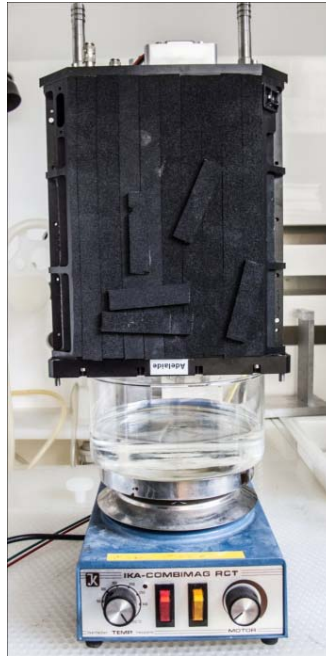
Figure 12. Detector surface inside AO wave-front sensor camera with open window directly above boiling alcohol

The following figures show another application where this cleaning method has been applied successfully. For our adaptive optics projects we are assembling a series of wave-front sensors where the various focal plane components (CCD detectors, lens-let array and window) are compacted to an extreme. The assembly and alignment of these elements cannot be done in a complete dust-free environment and moreover the pieces delivered are already dust-contaminated. Therefore here the vapour-method was very valuable to get cleaner results.

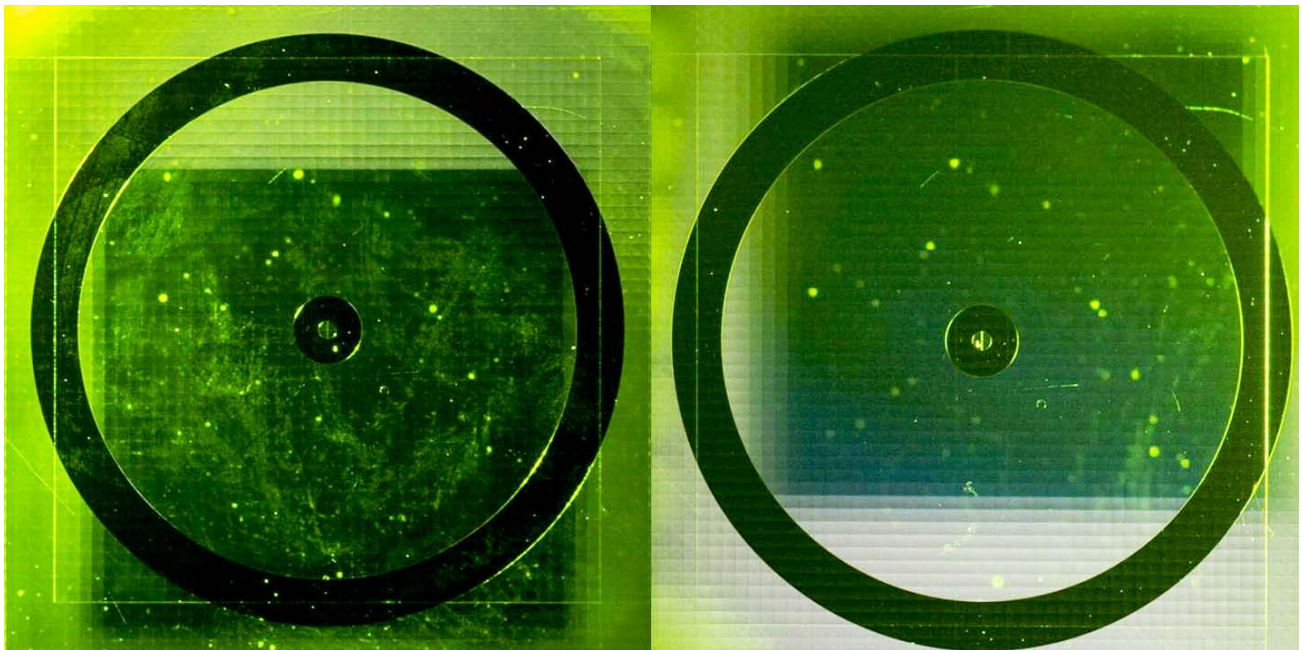
Figure 13. AO lens-let before (left) and after vapor cleaning (right); Note: Some dust and the not accessible backside of the lens-let could not be cleaned
