Introduction

FORS 1 De-contamination mission at PARANAL

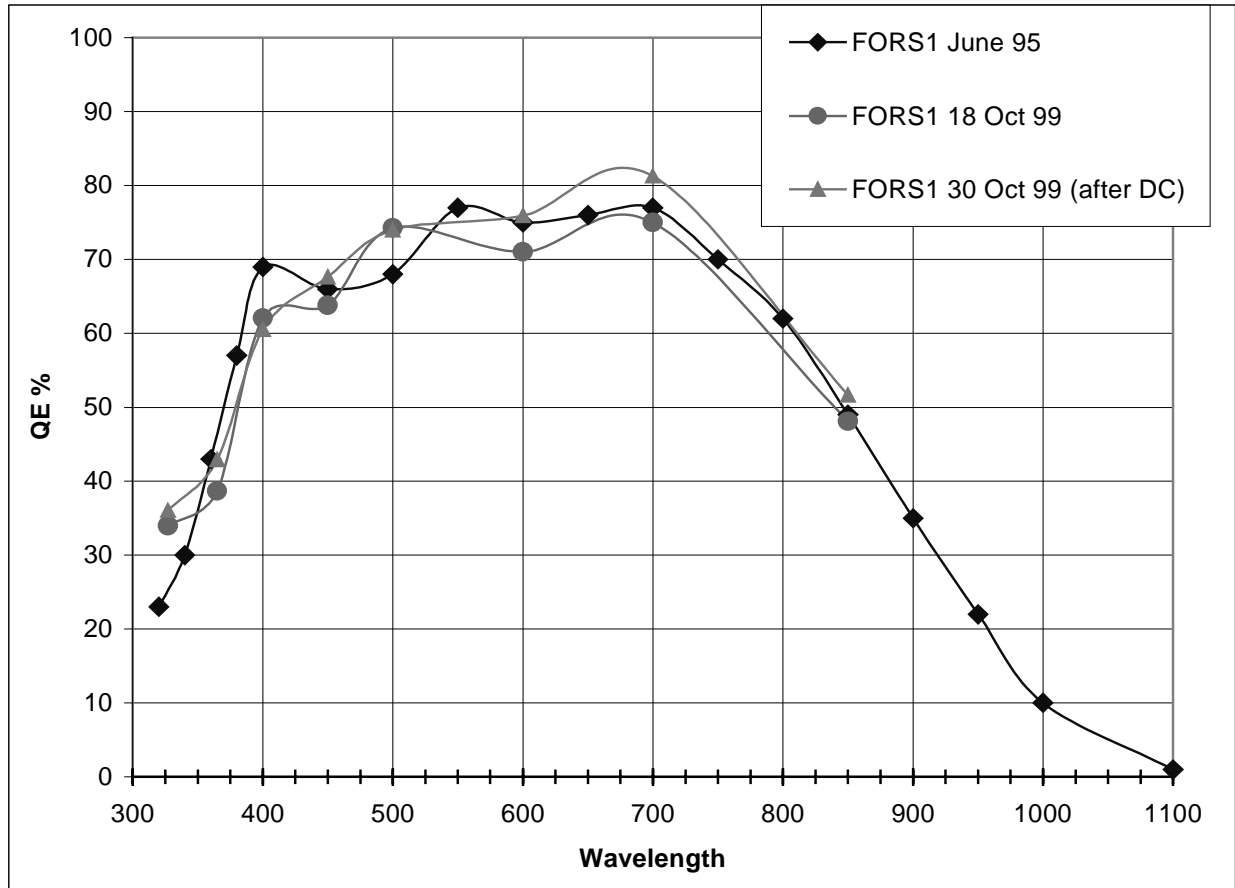
FOR1 CCD QE measurements, central 1cm² area = 416x416 pixels. This central area was barely contaminated.

As already measured with different CCD devices in Garching, the contamination has no effect on the QE in the center part of the CCD. The 30th October curve is smoother than the one from the 18th, before decontamination, because contamination behaves like a thin optical layer, leading to a small fringing effect in the QE curve. The CCD has been cooled down the 30th of October 1999, and flat field measurements could start on the 31st. So this date will be regarded as the T₀ date in the following text.

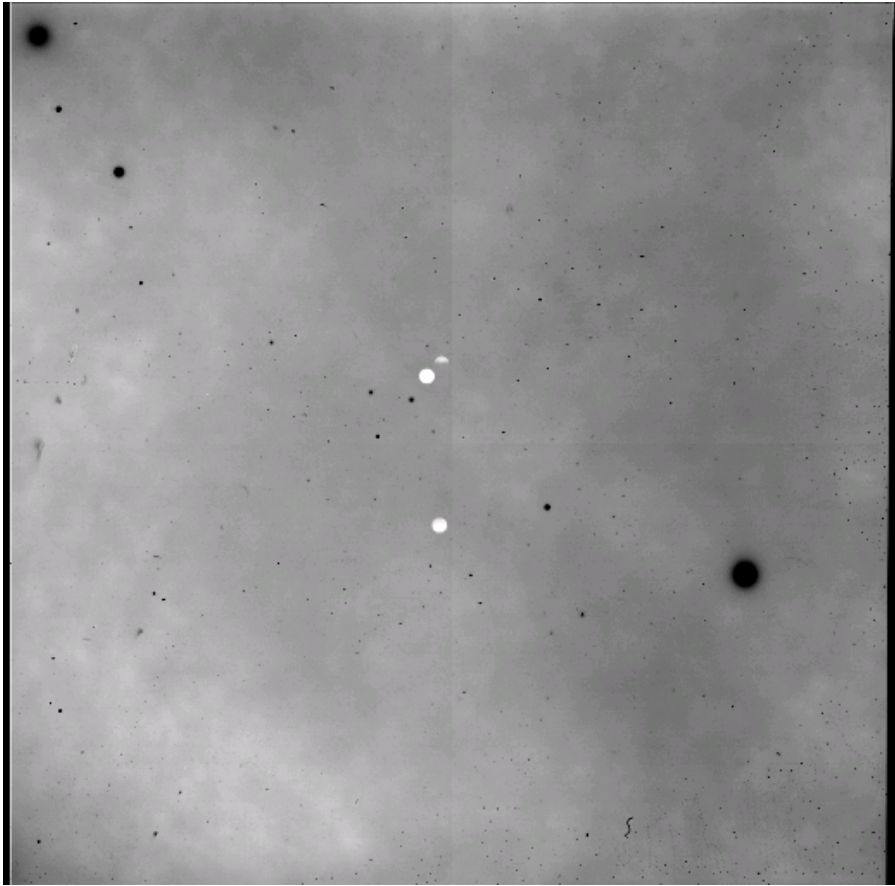
A U band flat field from the 31st of October, with lamp to LADC reflexion in the middle.

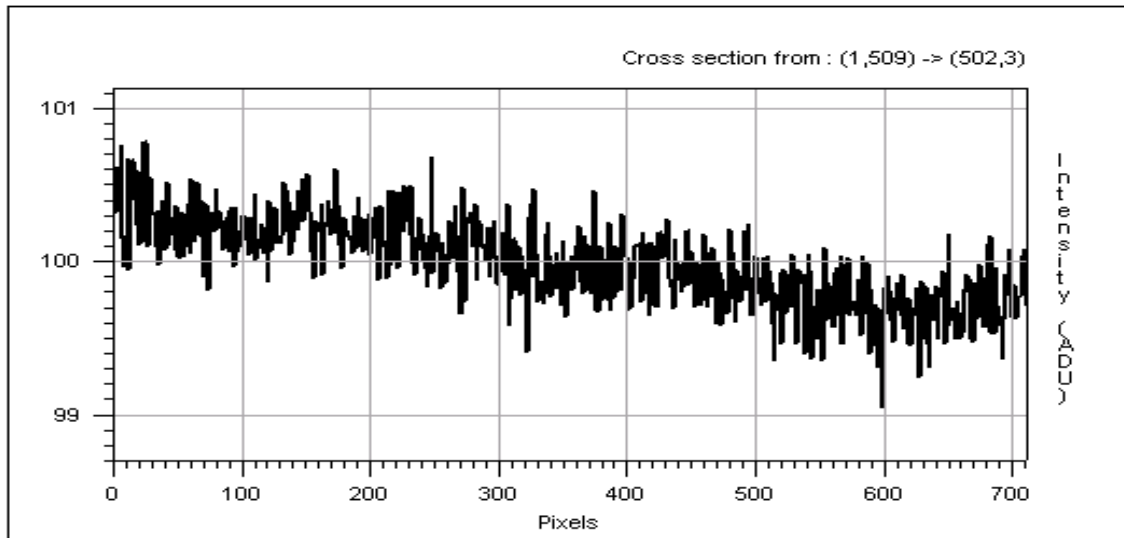
Diagonal cross-section, from top-left corner to the lower right from the previous frame. Normalized to 100,0.

After 1 day, nothing so far is visible, except a light gradient due to changes in illumination of the FORS instrument flat field screen. To avoid this gradient to hide a slight contamination, it was removed by dividing the D_u frame by a second order polynomial synthetic flat field, as shown hereafter:

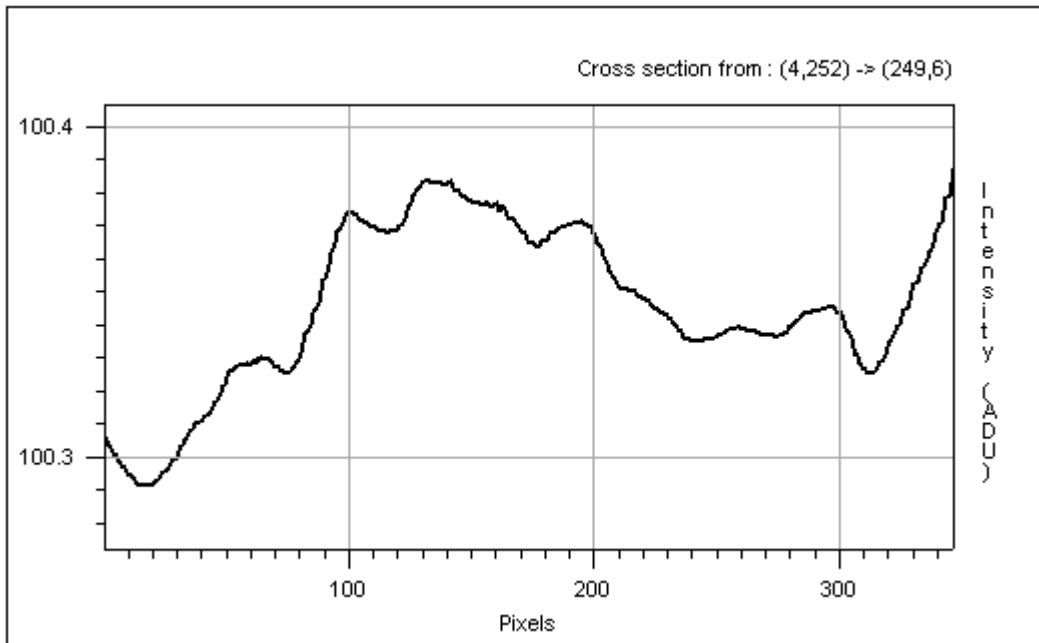
Diagonal cross-section, form left-top corner to the lower right from the DG_{red} frame at T_0+5 days, less than 0.1% relative QE loss in the top-left section. Normalized to 100,0.

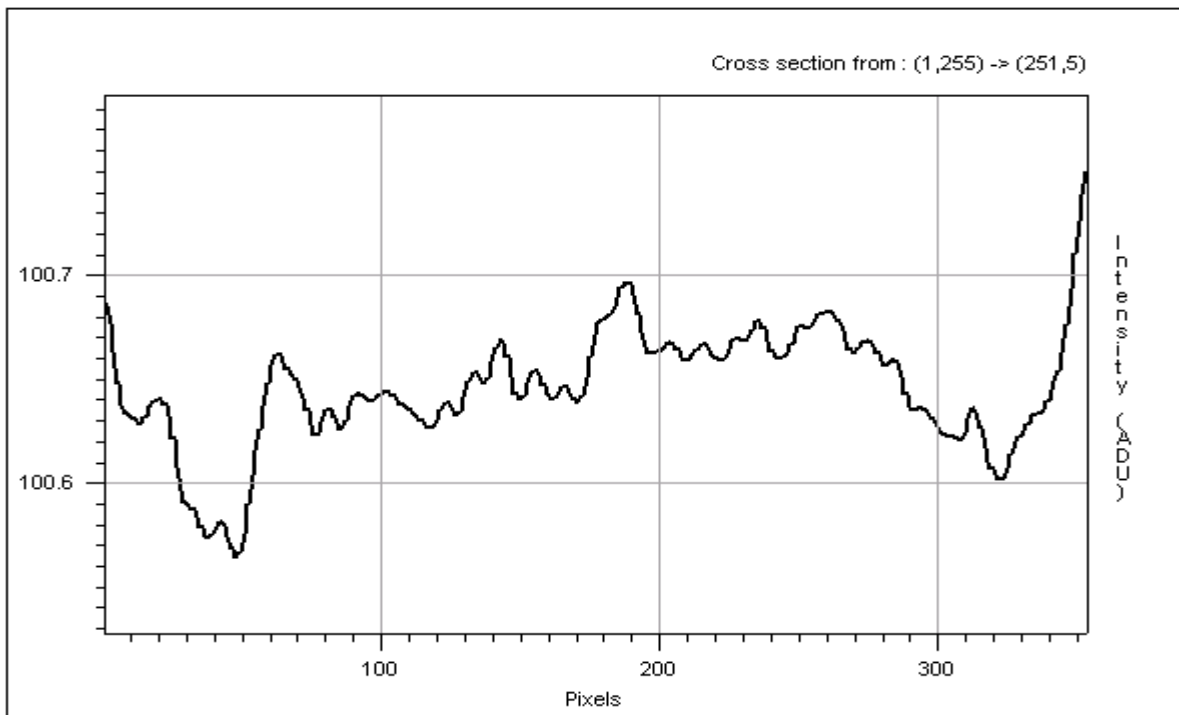
Diagonal cross-section, form left-top corner to the lower right from the DG_{red} frame at To+10 days, less than 0.2% peak-peak relative QE loss in the top-left section. Normalized to 100,0.

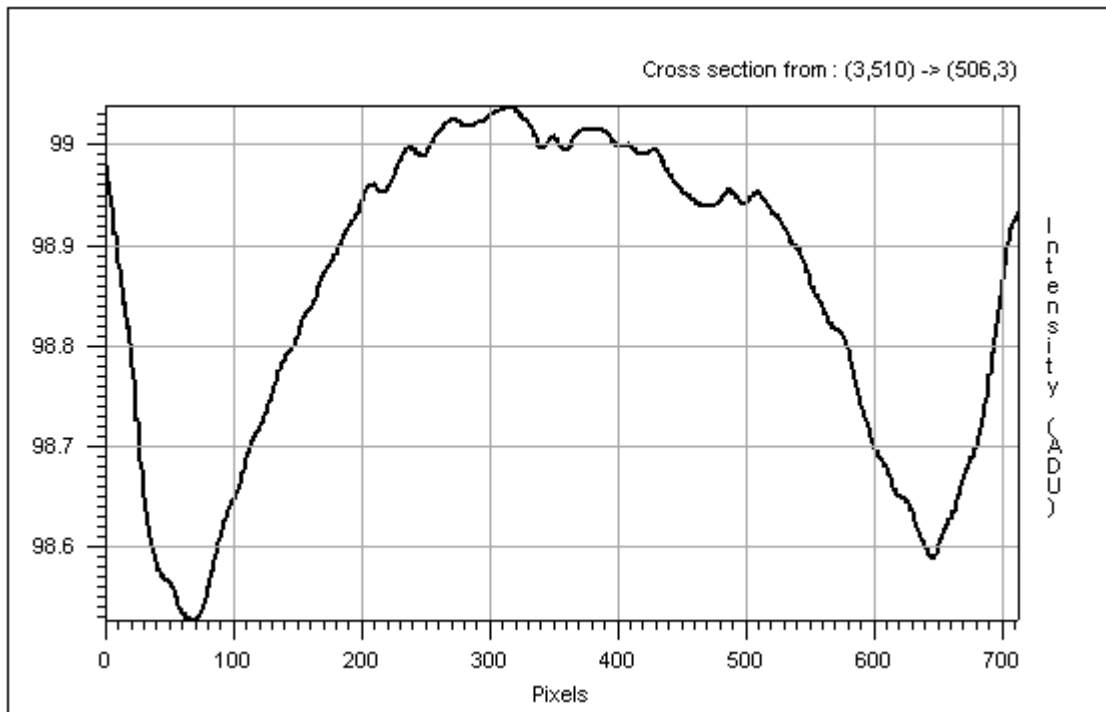
Diagonal cross-section, form left-top corner to the lower right from the DG_R frame at To+26 days, 0.5 % relative QE loss in the corners. Normalized to 100,0.

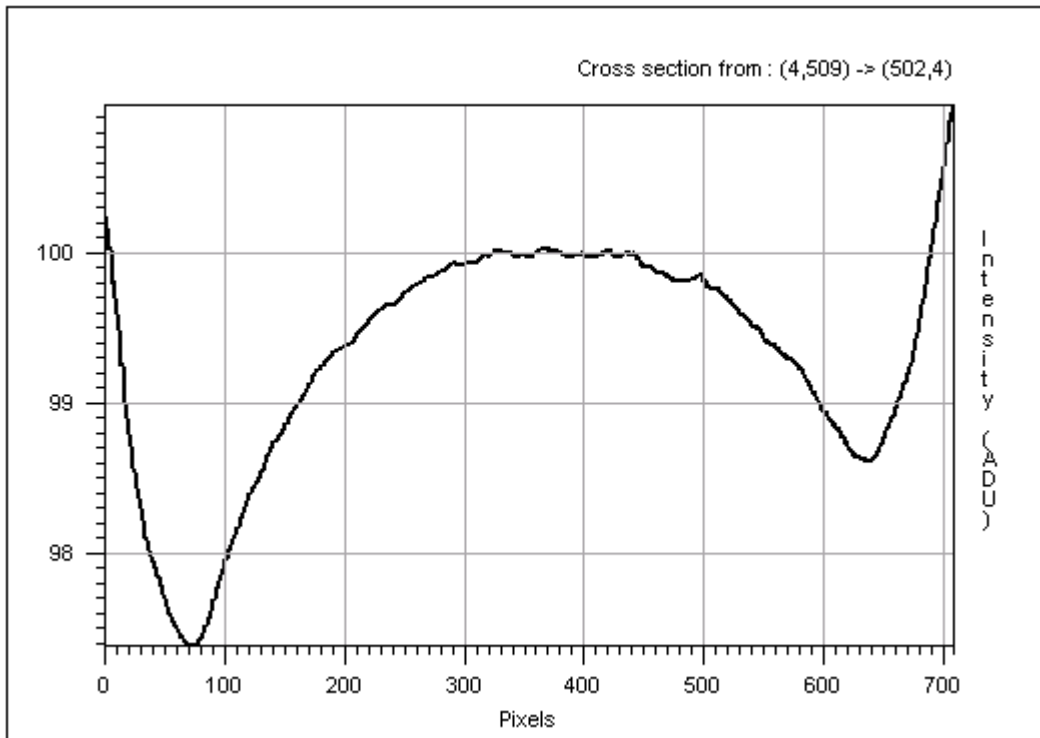
Diagonal cross-section, form left-top corner to the lower right from the DG_u frame at To+45 days, 3 % relative QE loss in the corners. Normalized to 100,0.

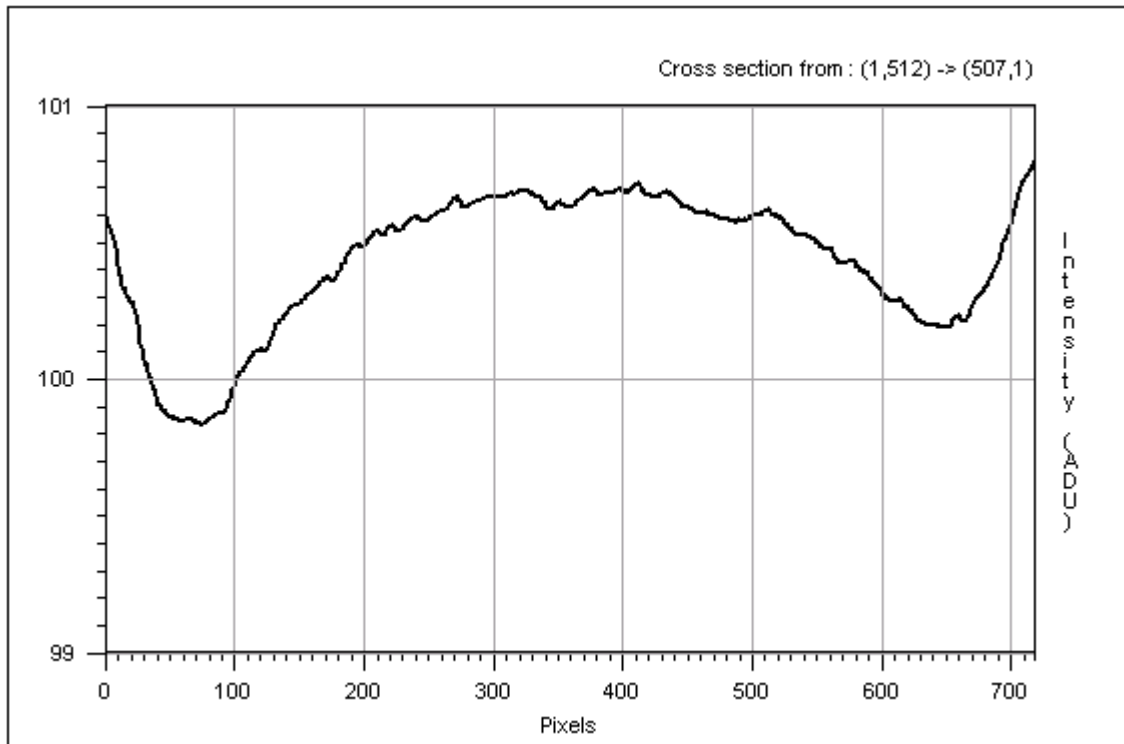
Diagonal cross-section, form left-top corner to the lower right from the DG_R frame at To+45 days, 0.8 % relative QE loss in the corners. Normalized to 100,0.

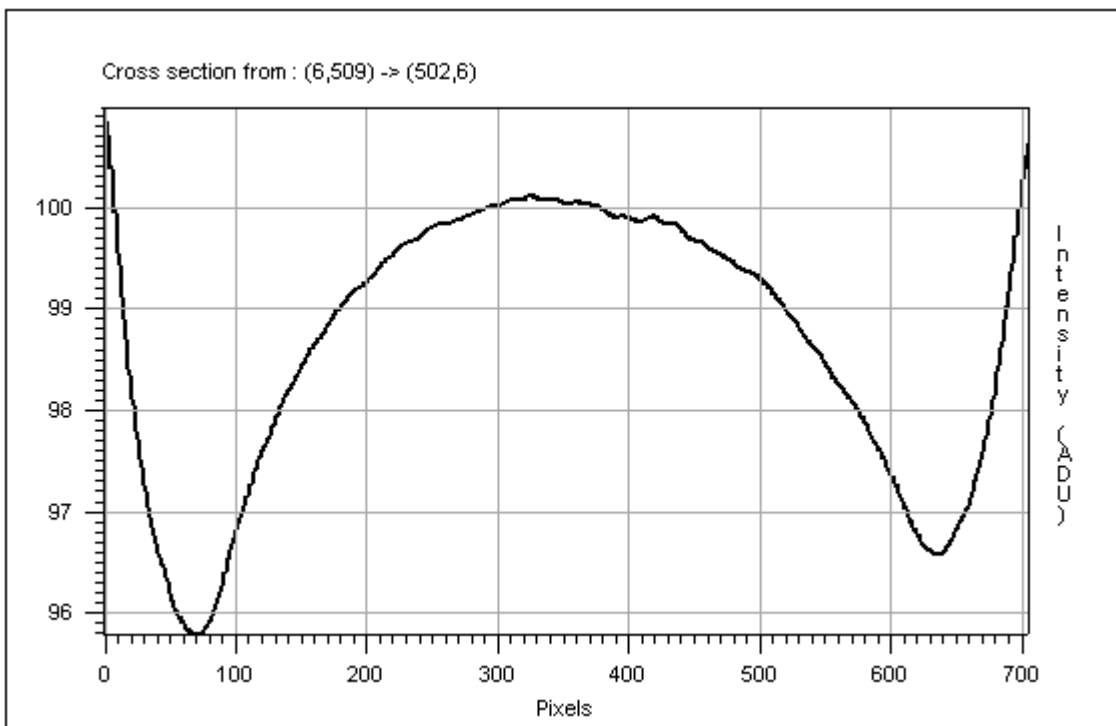
Diagonal cross-section, form left-top corner to the lower right from the DG_u frame at To+66 days, 5 % relative QE loss in the corners. Normalized to 100,0.

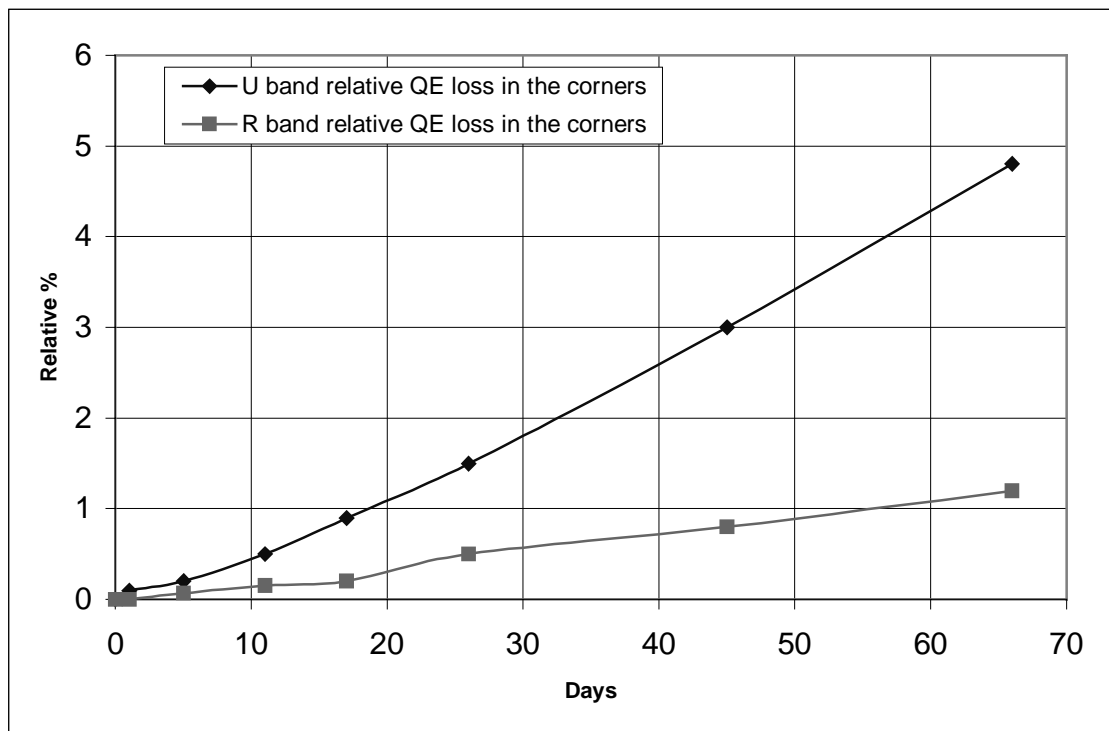
- The growing of the contamination from 31/11/99 to 17/11/99 is 0.9% peak-peak relative QE loss in the U band (which is 0.05% per day compared to 0.6% before decontamination, contamination rate has been decreased by a factor of 12). Just to remind the reader that within 17 days the contamination in U band frames was 13%.

Variation of relative QE loss over time (U band and R band).

- A long trend analysis should be carried out, by monitoring the growing of this pattern **once a week**. In the R band, which was the second most affected band, after 5 days, nothing significant is visible. After 17 days, barely 0.2% has been measured.
