The Visible and Infrared Survey Telescope for Astronomy (VISTA): Looking Back at Commissioning

Jim Emerson¹
Will Sutherland¹

The ESO near-infrared survey telescope, VISTA, is about to enter operation. Dry runs for VISTA's Public Surveys have been in progress since November 2009 and the full surveys will begin soon. Some points from the VISTA commissioning are outlined.

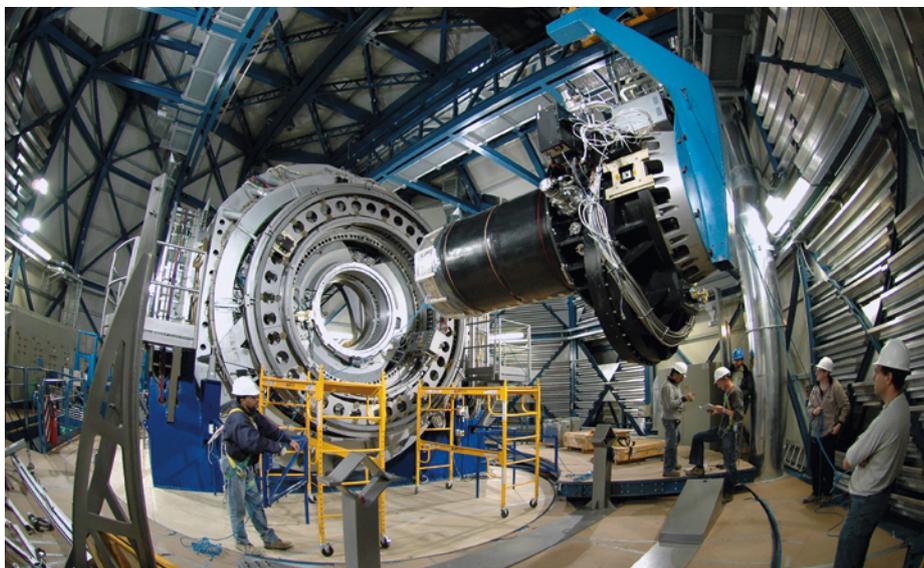
Figure 2. A view of VISTA's camera on the telescope with all the electronics boxes mounted (with their back covers off in this image). The open lifting hatch can be seen on the right, with the yellow crane above. The white circle at the top serves both as a Moon screen, and as a screen for taking linearity sequences and instrument health monitoring frames.

Shortly afterwards, the secondary mirror (M2) arrived and was successfully coated in protected silver. VISTA's camera was flown to Chile in January 2007 and checked out for performance on site, using a small "spot projector" mounted in front of the window. There had been no damage in transport, and the process of mounting the camera onto the telescope was subsequently tried out successfully (see Figure 1). Figure 2 shows the back view of VISTA, with the camera and its electronics boxes mounted on the Cassegrain rotator.

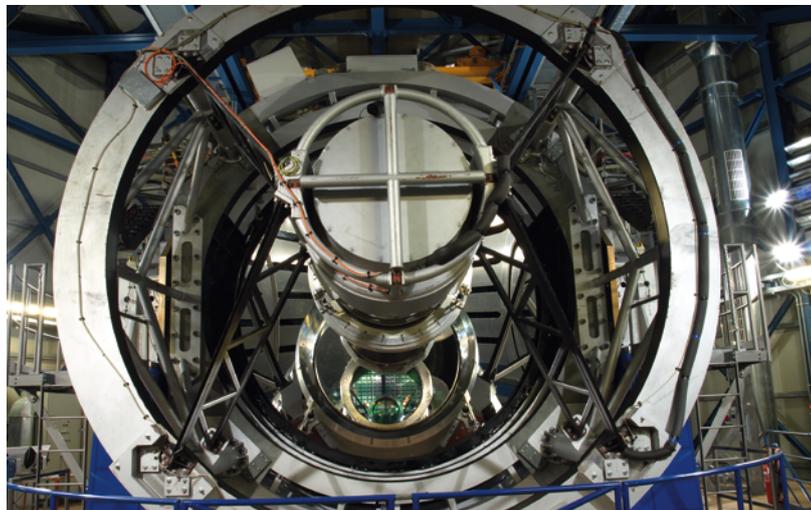
Figure 4. The VISTA telescope shown from the front at low elevation.

subsequent nights with various adjustments to the many M1 and M2 positions and forces. The pointing and tracking was good. Figure 4 shows VISTA from the front with all components present and working. No mechanical adjustments were needed to the camera, a tribute to the engineering done by the camera team led by the Science and Technology Facilities Council (STFC) run Rutherford Appleton Laboratory.

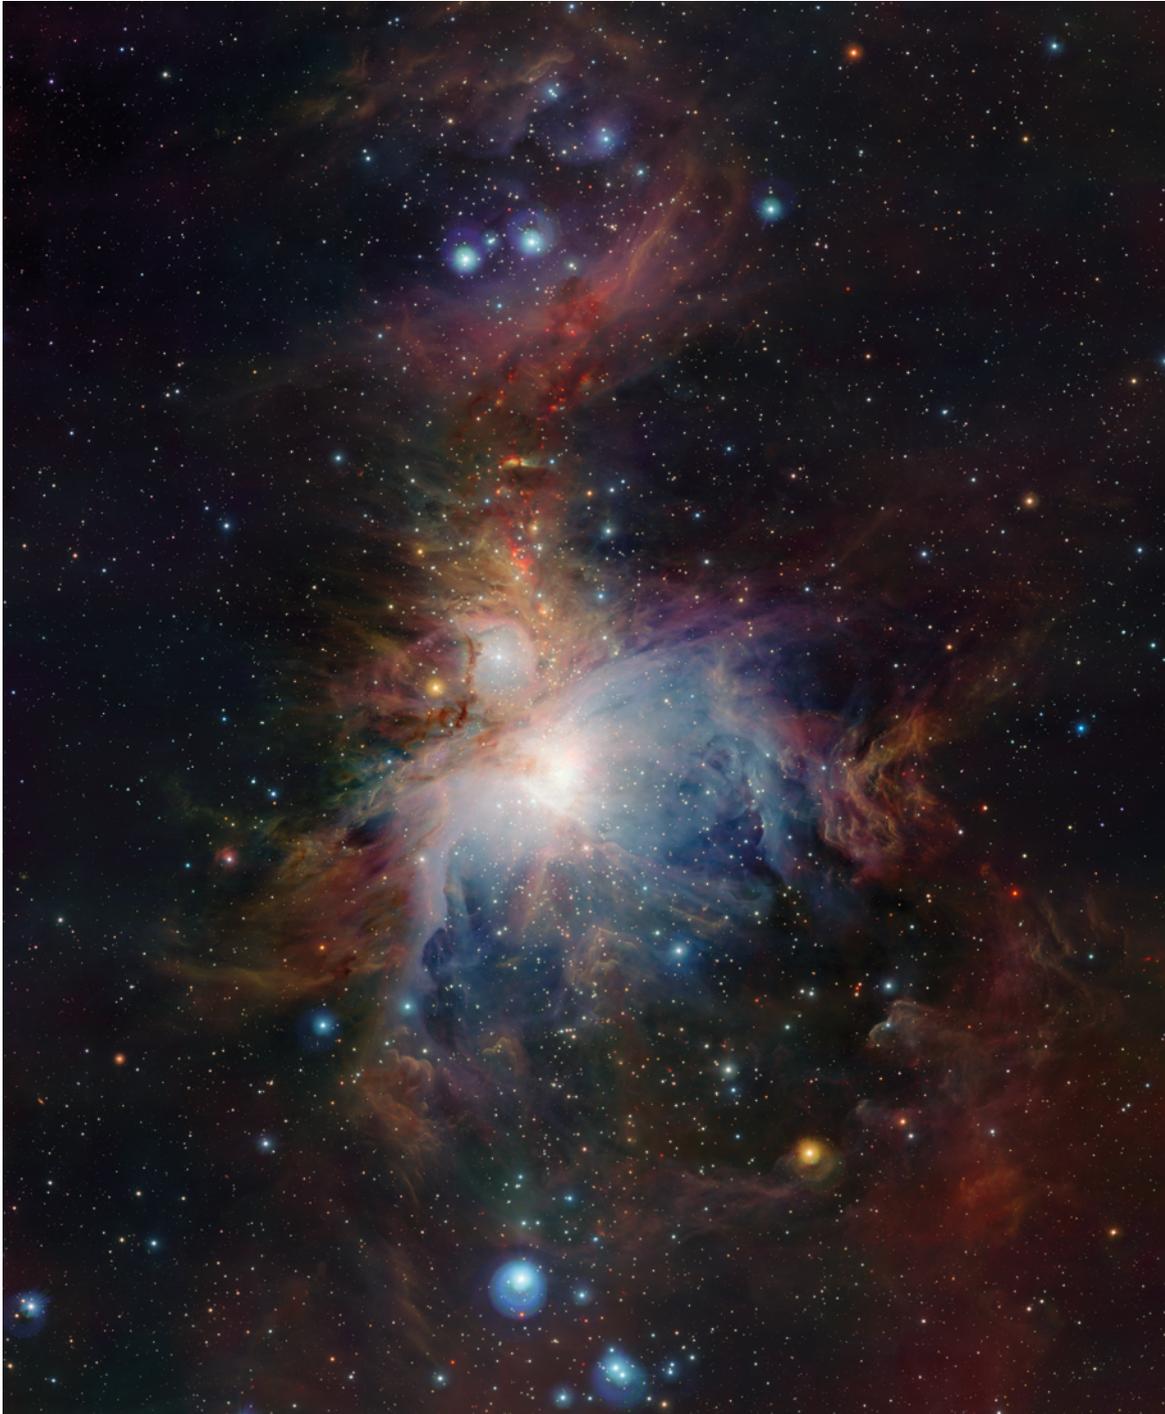
Figure 5. Orion Nebula (M 42 and M 43) composite image in ZJKs filters is shown. See ESO Press Release eso1006 for more details.

expected, with minor improvements being worked on to further enhance its reliability. The VISTA ZJKs 1×1.5 degree image of the Orion Nebula in Figure 5, of which the front cover image is a only a small part, indicates how impressive its wide-field views are.
